**ACCIDENT INVESTIGATION**

**Case No. 90-02**

AIRBAG INVESTIGATION

NHTSA In-Depth Airbag Accident Investigation Case 90-02

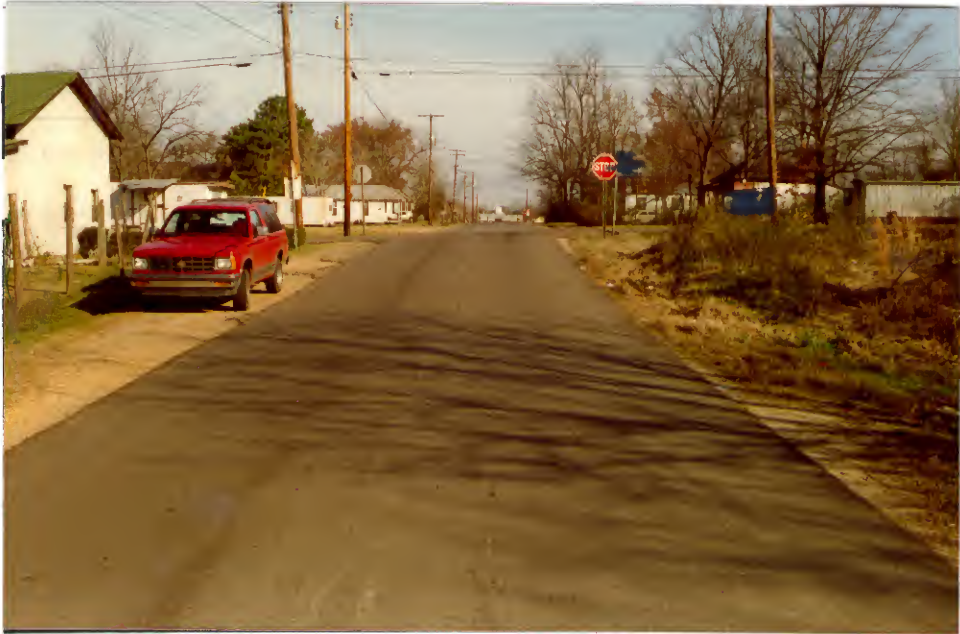
1. Pre-impact travel of the 1990 Dodge Spirit (airbag vehicle)\ north on [REDACTED] Street in [REDACTED] Arkansas.

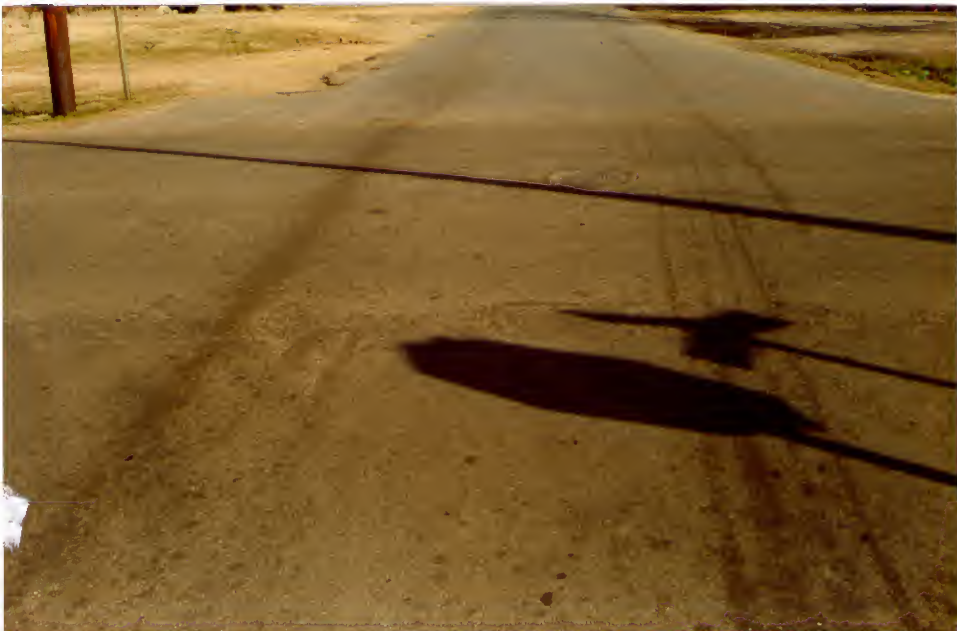
2. Area of impact of the Spirit with the 1979 Pontiac Grand Prix, and final rest area of the Spirit.

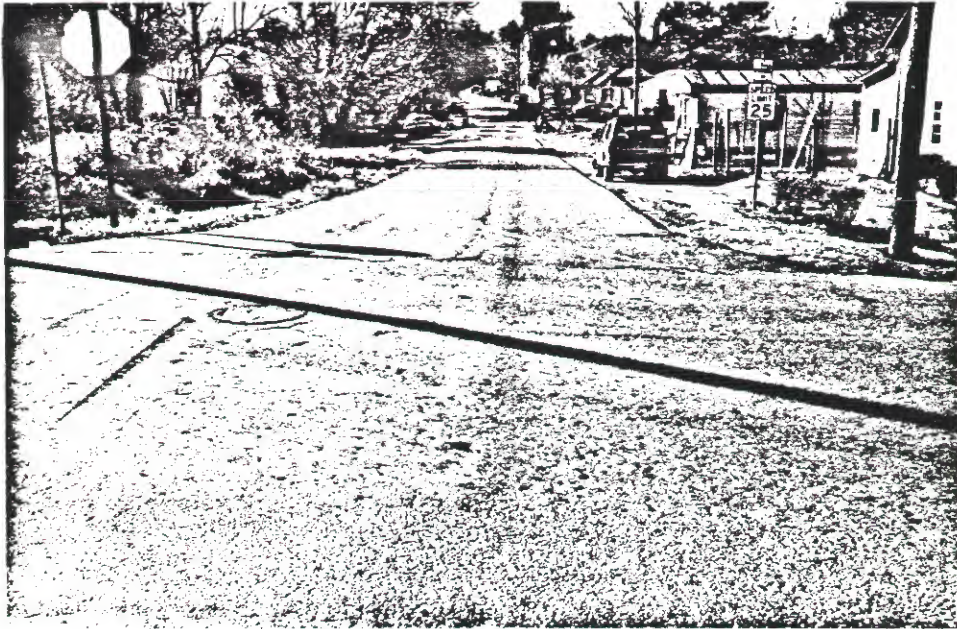
3. Opposite view from beyond impact looking south.

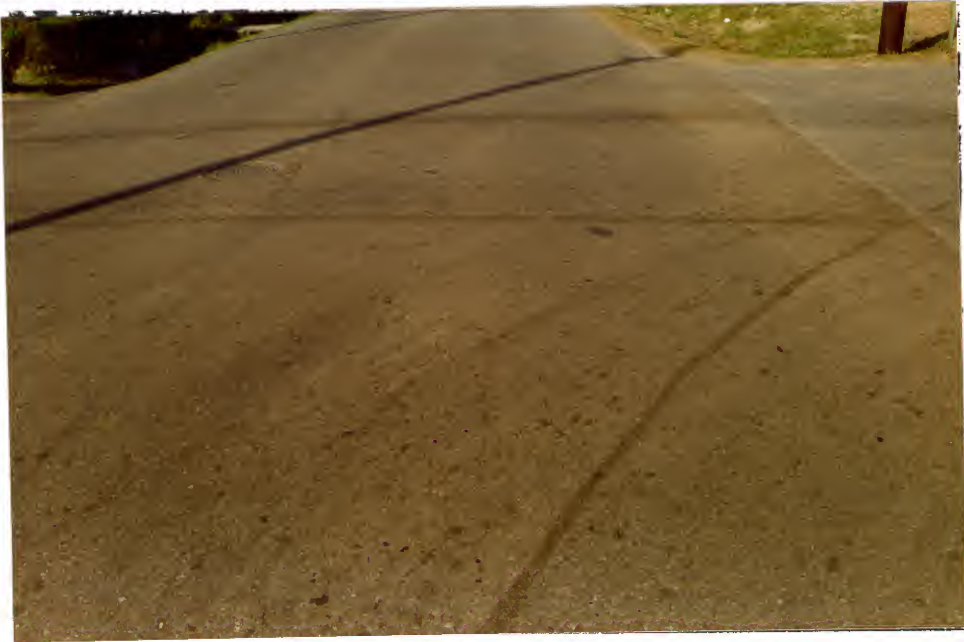
5. Area of impact looking west.

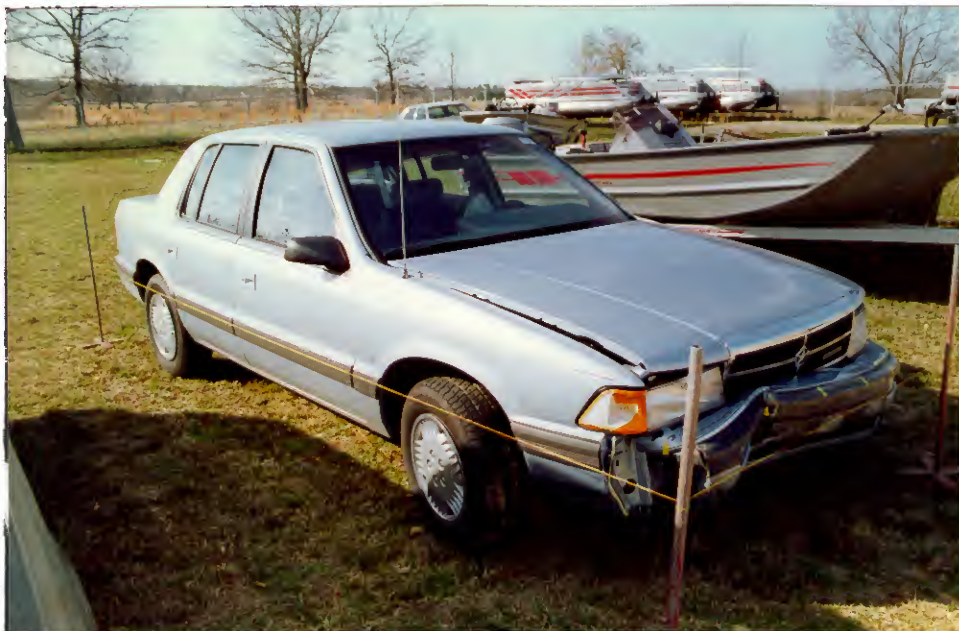
Damaged exterior components included the front bumper, grille, hood, right front fender, right front parking lamp.

6. Front-right overall view of the 1990 Dodge Spirit.

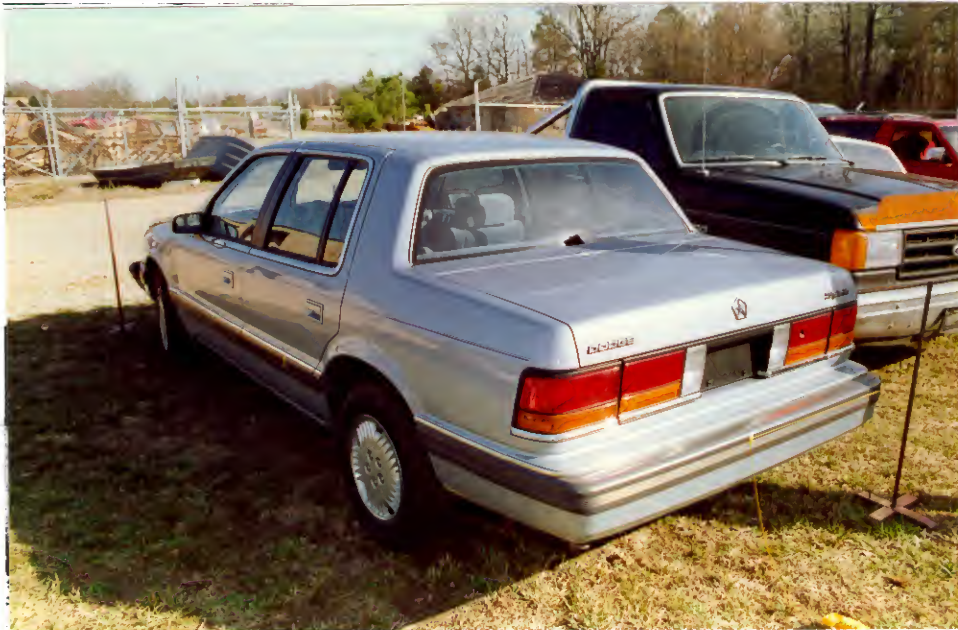
8. Rear-left overall view of the Spirit.

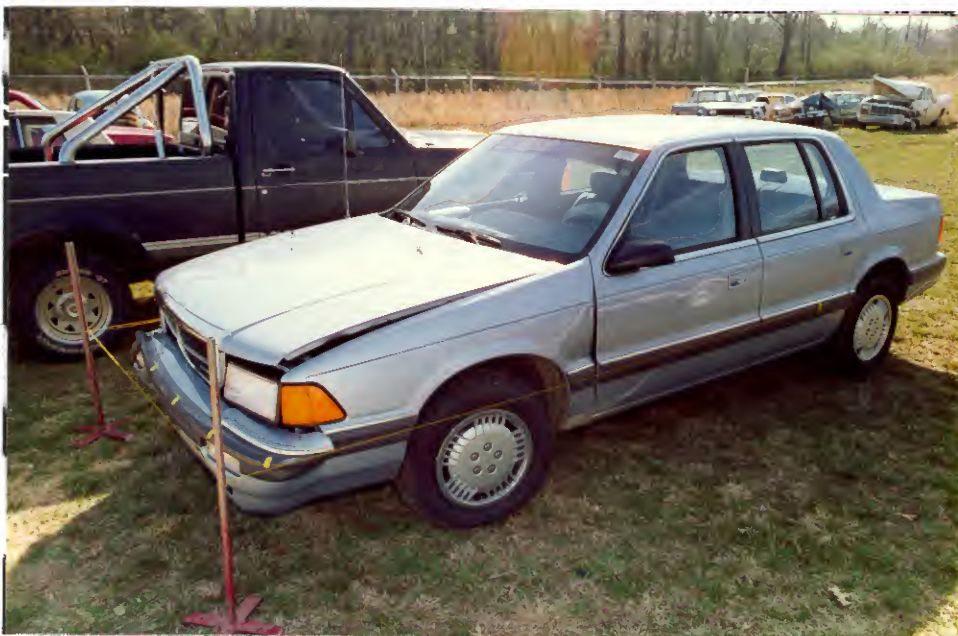
9. Front left overall view of the Spirit.

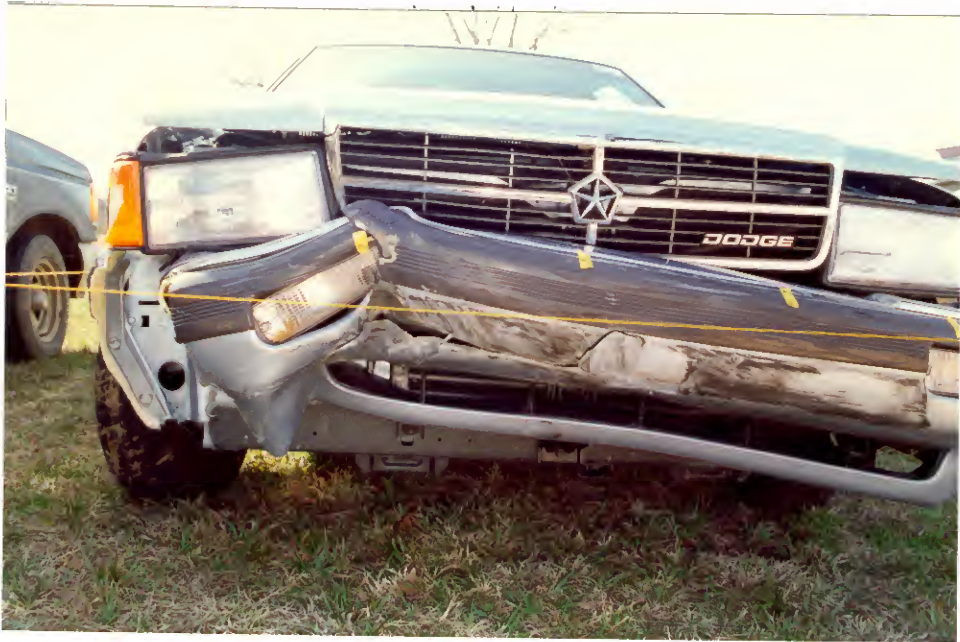
A CDC of 02-FDEW-1 was assigned to the damage to the Spirit, with a maximum residual crush of 4.2 inches. Damaged exterior components included the front bumper, hood, right front fender, grille, and right parking lamp. Damaged interior components included the steering assembly and airbag components. The Spirit was disabled in the crash and towed to a local storage facility. The Grand Prix was driven away following the police investigation of the accident. A CDC of 11-LZEW-2 was assigned to the damage to the Grand Prix, with a maximum residual crush of 6.0 inches.

10. Close-up view of frontal impact area.

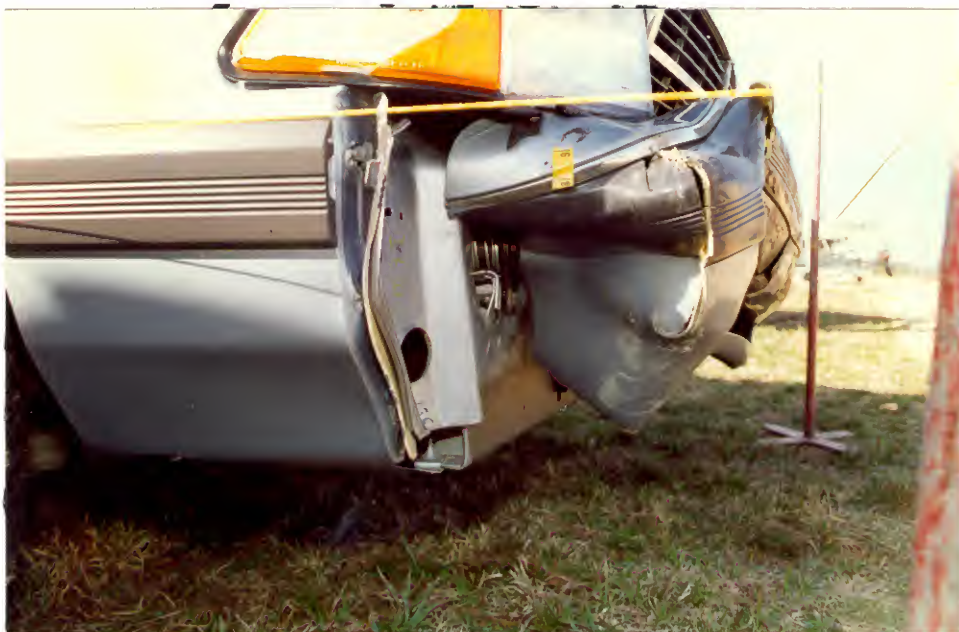
11. Front-right corner view of the Spirit.

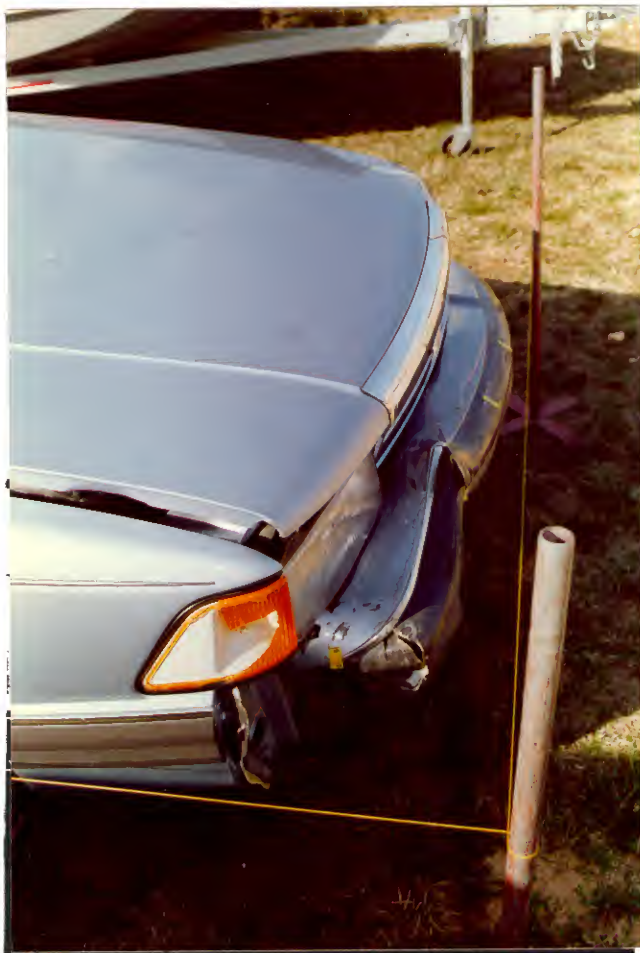
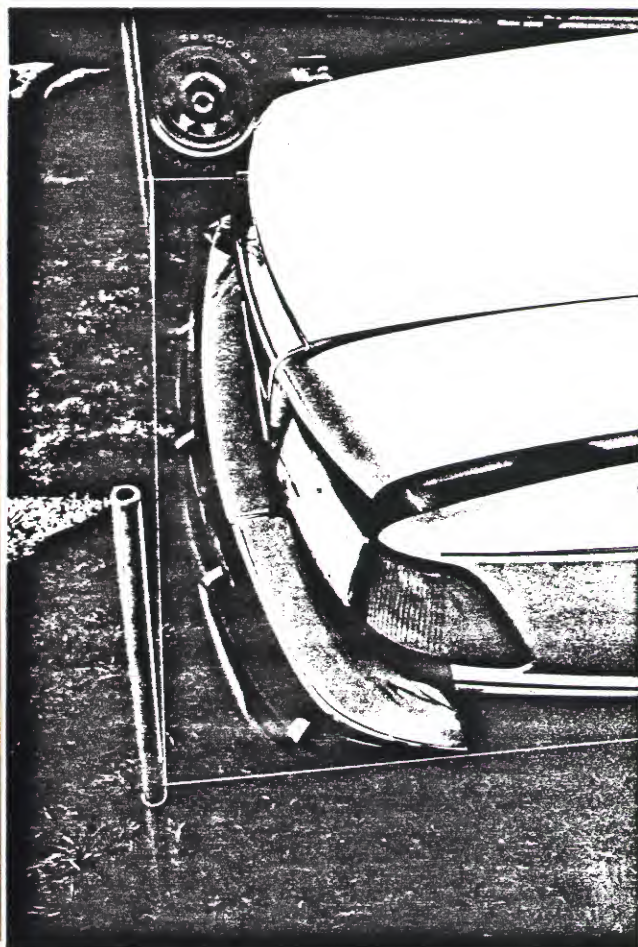
12-13. Views down front stringline showing rearward crush of the bumper.

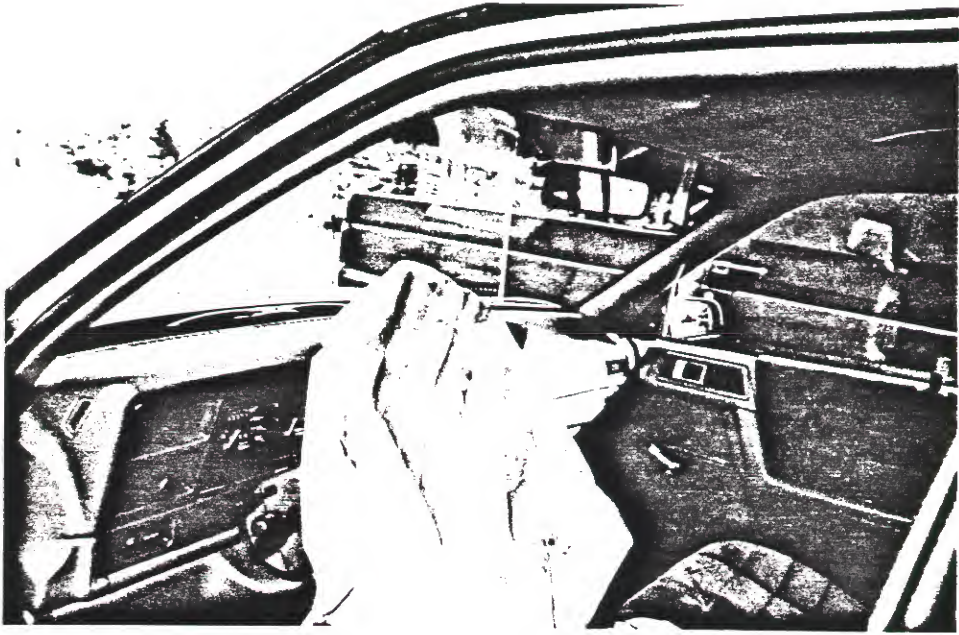
Interior damaged components were the steering assembly and airbag module.

14. Overall view of frontal interior.

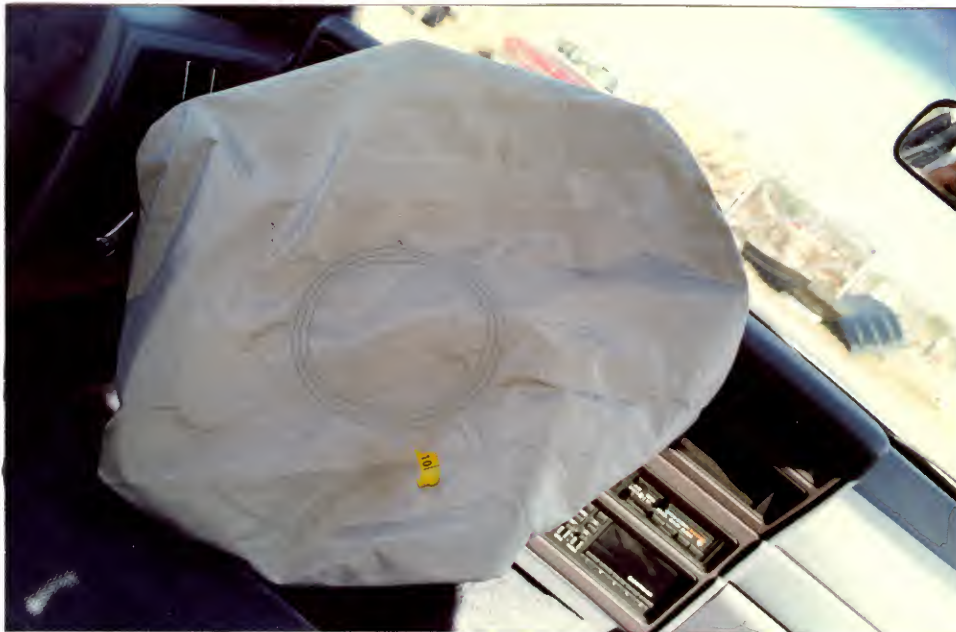
The driver's side airbag restraint system deployed as a result of the frontal impact. The driver responded to the impact force by moving forward and to the right relative to the vehicle interior, loading the deployed airbag module with her face and upper torso. She stated that she sustained a laceration of her inner upper lip from the impact force with the deployed airbag. Occupant contact to the airbag was noted during the inspection of the vehicle.

15. Overall view of deployed airbag showing occupant contact.

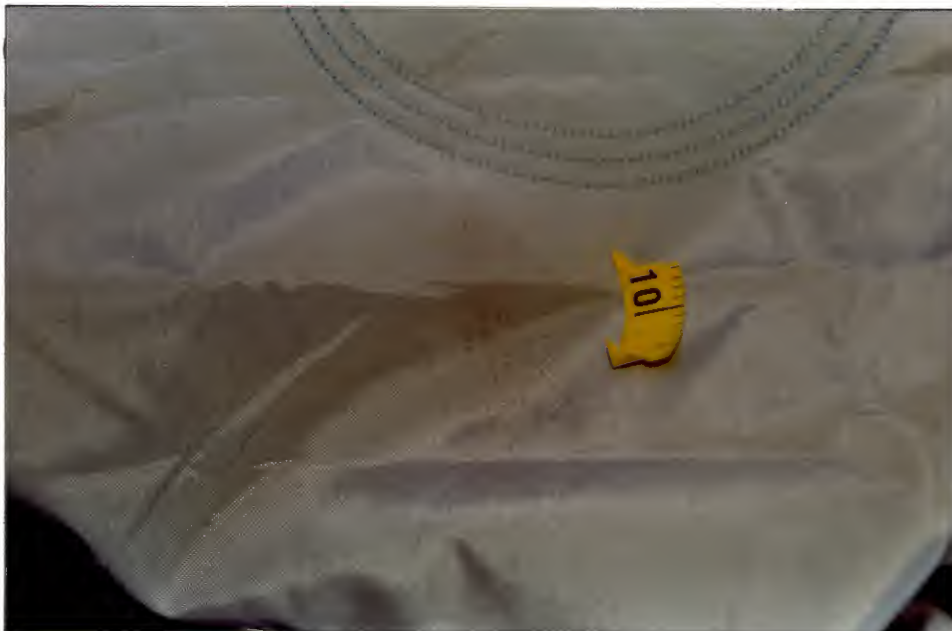
16. Close-up of occupant contact to the deployed airbag.

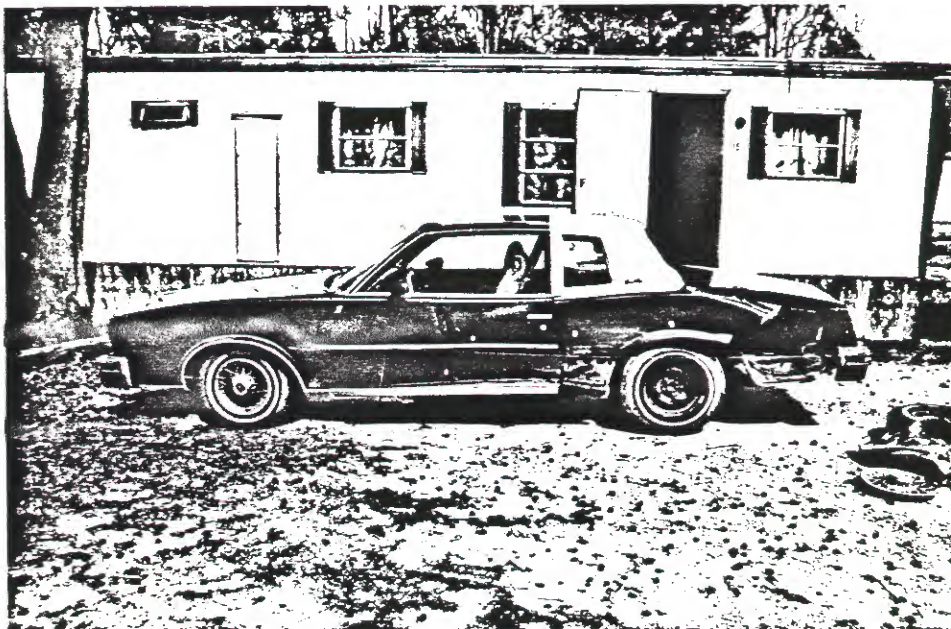
17. Left side view of the 1979 Pontiac Grand Prix.

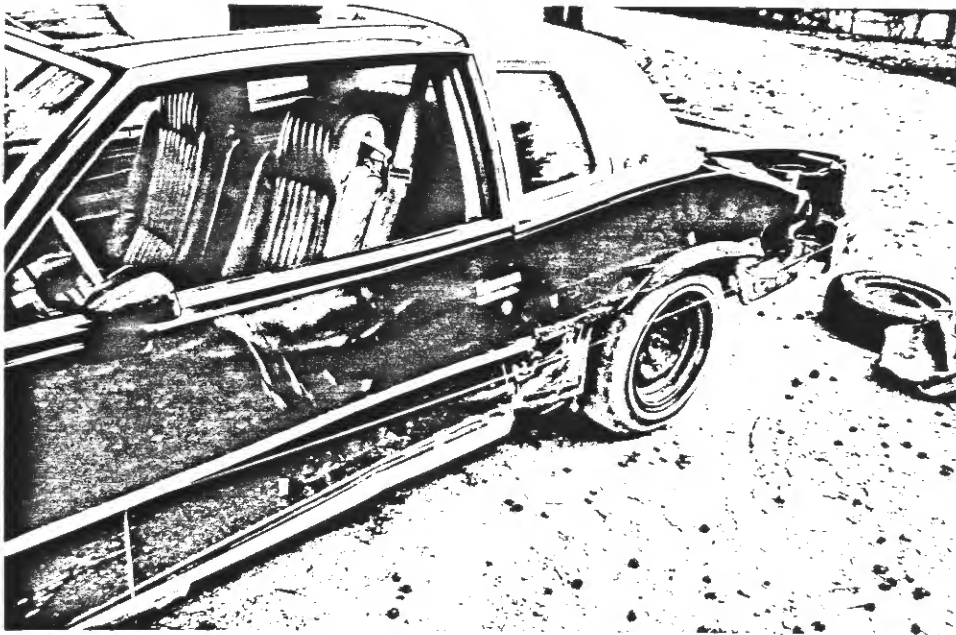
Damaged exterior components included left side door, left rear quarter panel, left rear wheel, and wheel cover.

19. Closeup view of damage to the Grand Prix.

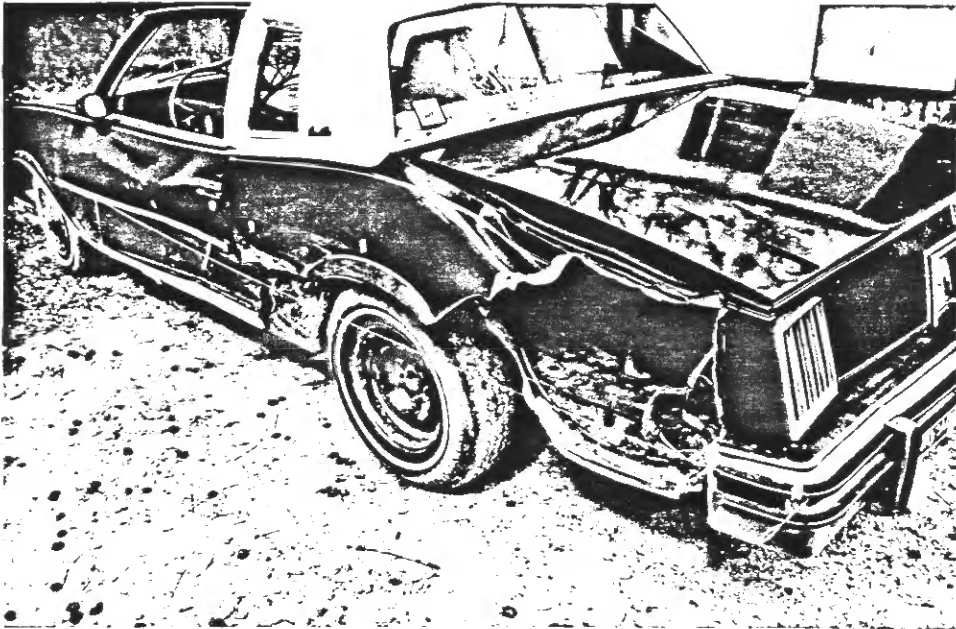
20. Additional close-up view of left side damage.

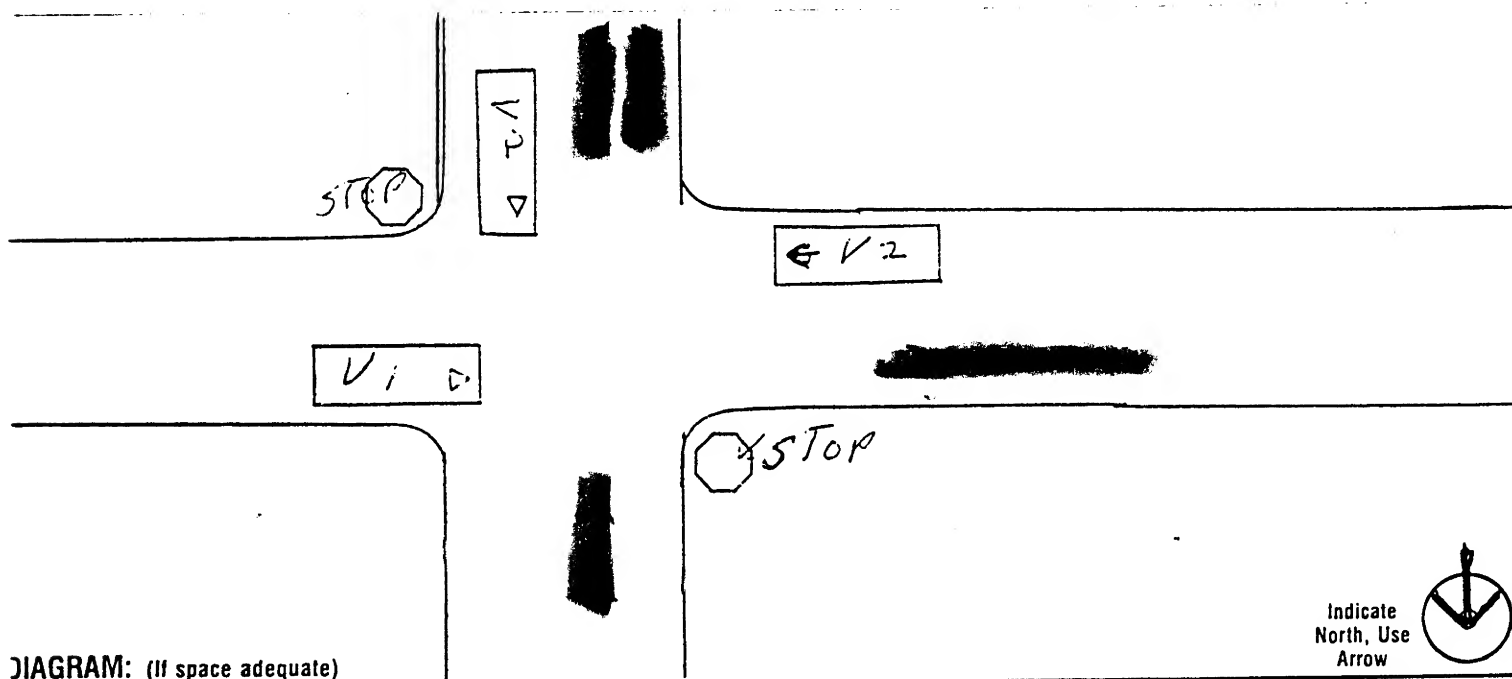
**DIAGRAM: (If space adequate)**

VEH. 2 WERE GOING NORTH AND FAIL TO YIELD AT STOP SIGN.

VEH. 1 WAS KNOCK AROUND AND HEADED BACK EAST.

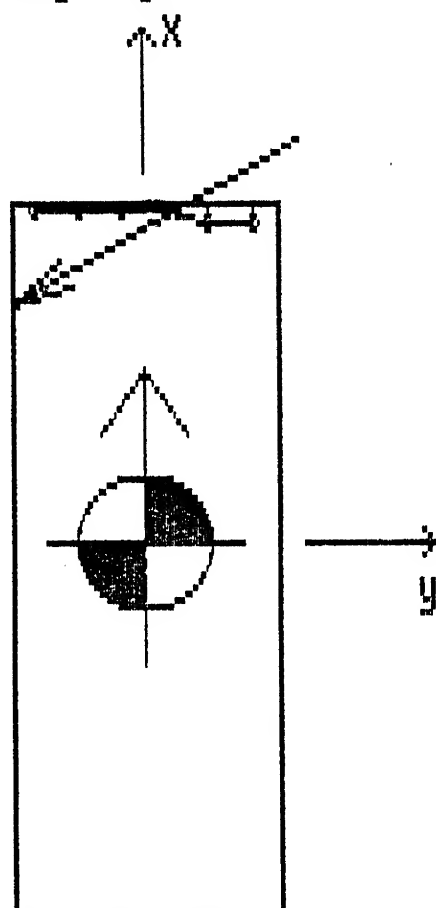
1990 Dodge Spirit

CDC/PDOF: 02FDEW1 60.0 deg  
Max. Impact Force: 50180 lb

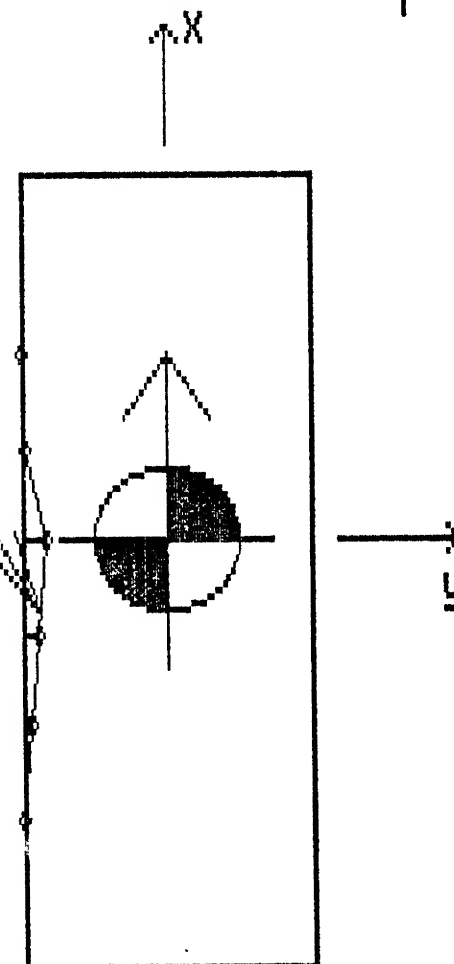
1979 Pontiac Grand Prix +

CDC/PDOF: 11LZEW2 -30.1 deg  
Max. Impact Force: 73328 lb
